# **DESCHUTES BASIN HABITAT CONSERVATION PLAN STUDY REPORT**

## **Study 14: Assessment of Fish Passage and Screening at Diversions Covered by the DBHCP – Phase 1**

**Deschutes Basin Board of Control, and  
City of Prineville, Oregon**

**Biota Pacific Environmental Sciences, Inc.  
And  
R2 Resource Consultants, Inc.**

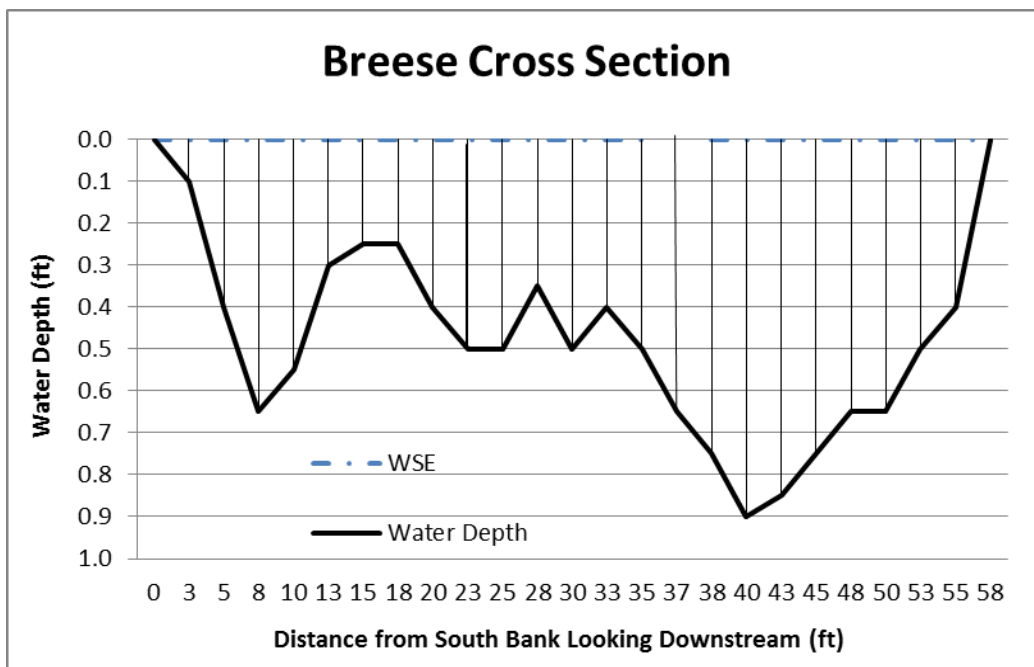
**Figure A-2. Cross section of Ochoco Creek 10 feet upstream of Breese Diversion.**
